APPROVALS		DATE				
	DRAWN Rick Price		05-30-03	ROTORCRAFT FLIGHT MANUAL SUPPLEMENT			
	CHECKED Gordon Pratt		05-30-03				
	ENGINEER Mark McCormack		05-30-03	SIZE A	CAGE CODE 1B7G3	DWG NO. 150-045709	REV B
	ISSUED Mark McCormack		05-30-03	SCALE: NONE		DO NOT SCALE DRAWING

FAA APPROVED  
ROTORCRAFT FLIGHT MANUAL SUPPLEMENT  
For  
CHELTON FLIGHTLOGIC EFIS as installed in  
BELL HELICOPTER MODEL 206 Series

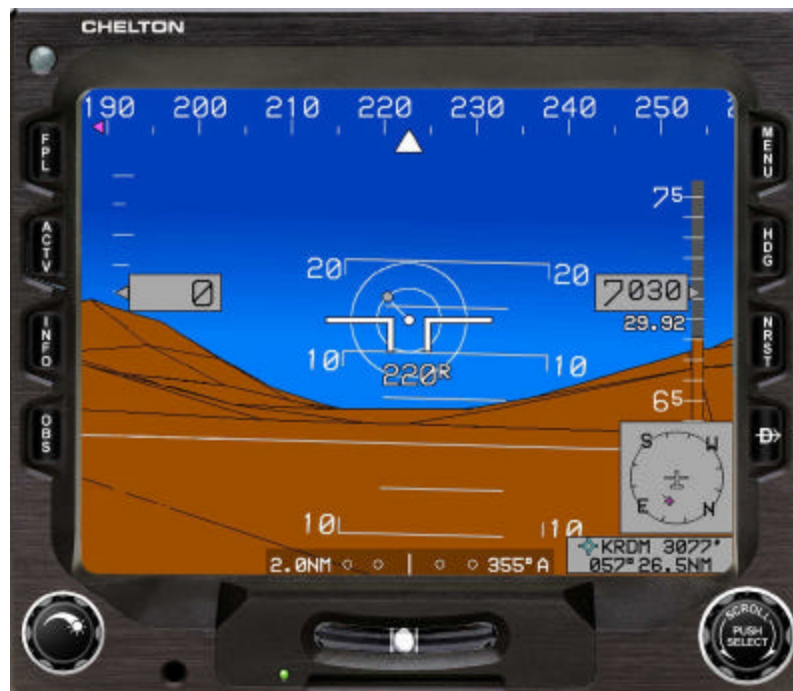
Figure 3: Hover-Vector Display

Whenever the airspeed is below 30 kts., the flight path marker and waterline are replaced with conventional attitude bars and the hover vector. The hover vector is centered on the attitude bars and is used to indicate direction and groundspeed of drift at low airspeeds.

The inner concentric ring indicates 15 kts ground speed (GS) and the outer concentric ring indicates 30 kts. The 30 kt ring will appear when the GS exceeds 15 kts. The white dot indicates 0 kts. The gray dot indicates the direction of drift, as viewed from above (straight up, the 12:00 position, equates to forward flight while straight down, the 6:00 position, equates to rearward flight). Groundspeed is determined by the location of the gray dot over the concentric rings.

The example below indicates the helicopter moving forward and to the left (10:00 position) at 15 kts.

FIGURE 1: PRIMARY FLIGHT DISPLAY.....	6
FIGURE 2: MULTI-FUNCTION DISPLAY.....	6
FIGURE 3: HOVER- VECTOR DISPLAY.....	7
